## EXECUTIVE SUMMARY

### Event Description

On July 24, 2007, starting at 1:46 pm, multiple circuit breakers operated (opened and reclosed) at the Martin substation five times over a period of thirty-five minutes. The individual events consisted of the simultaneous actuation of multiple breaker failure relays that tripped the associated circuit breakers. These events resulted in momentary interruptions of service to 26,899 customers fed from the Embarcadero Substation (including Substation J) and in sustained interruption of service to 27,132 customers fed from Martin Transformer Bank #1.

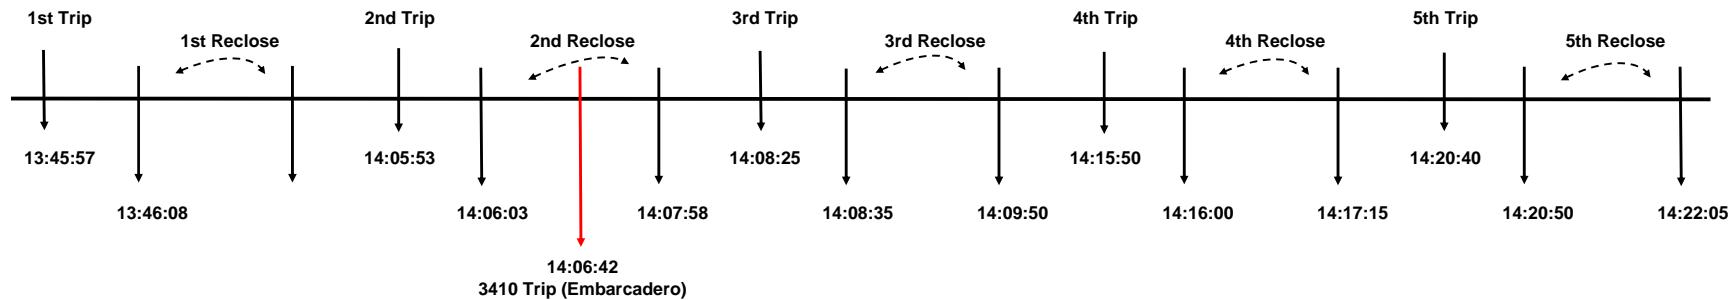
**FIGURE 1: Event Timeline**

On July 24, 2007, starting at 1:46 pm, multiple breakers operated (opened and reclosed) at Martin Substation five times over a period of thirty-five minutes. This resulted in momentary interruption of service to 26,899 customers fed from the Embarcadero Substation (including Substation J) and sustained interruption of service to 27,132 customers fed from Martin transformer bank #1 (see Figure 1). The individual events consisted of the actuation of multiple breaker failure relays that initiated trips of the associated circuit breakers.

Between the first and second Martin events (see Figure 1), a network transformer failed at Mission and First Streets in San Francisco. The transformer failure did not result in an interruption of service to customers. There is a separate investigation into the root cause for the network transformer failure.

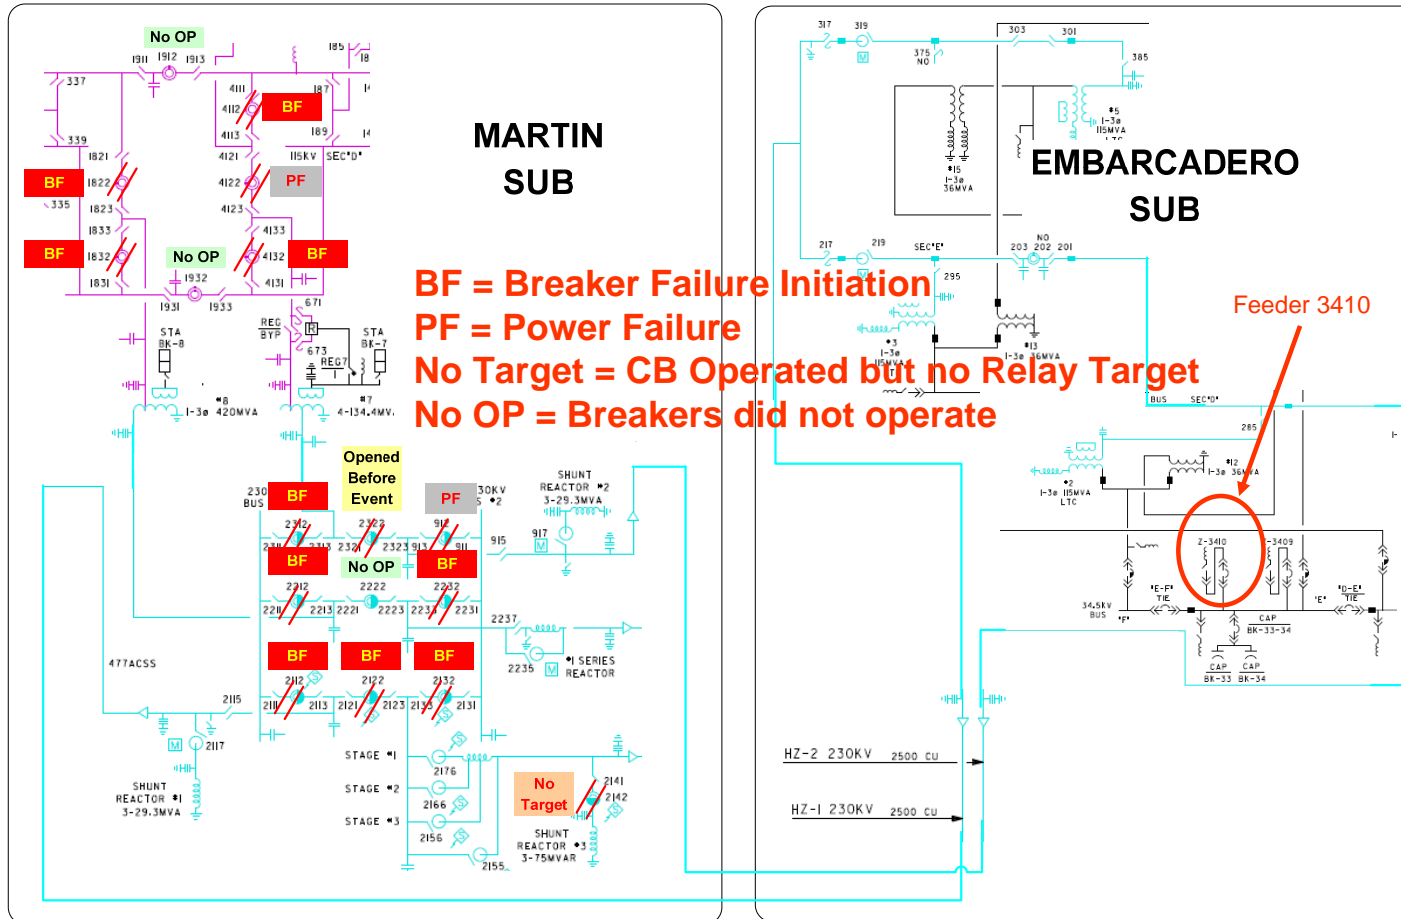
**FIGURE 2: Breaker Status During July 24 Event**

- Twelve breaker failure relays showed that each relay received input signals (on input 3) and opened the associated breakers almost simultaneously (see Figure 2).
  - Two breakers were tripped due to power failure (loss of voltage on both sides of the breaker), which is an expected event since this is how the system is designed to operate (see Figure 2).
  - One breaker did not operate (see Figure 2).
  - Breakers reclosed normally by automatic controls, as designed.
  - The trip and reclose cycle occurred five times over an approximate thirty-five minute period of time.
  - There were no other relays that operated prior to the event.
- Employees at Martin Substation were interviewed and it was learned that:

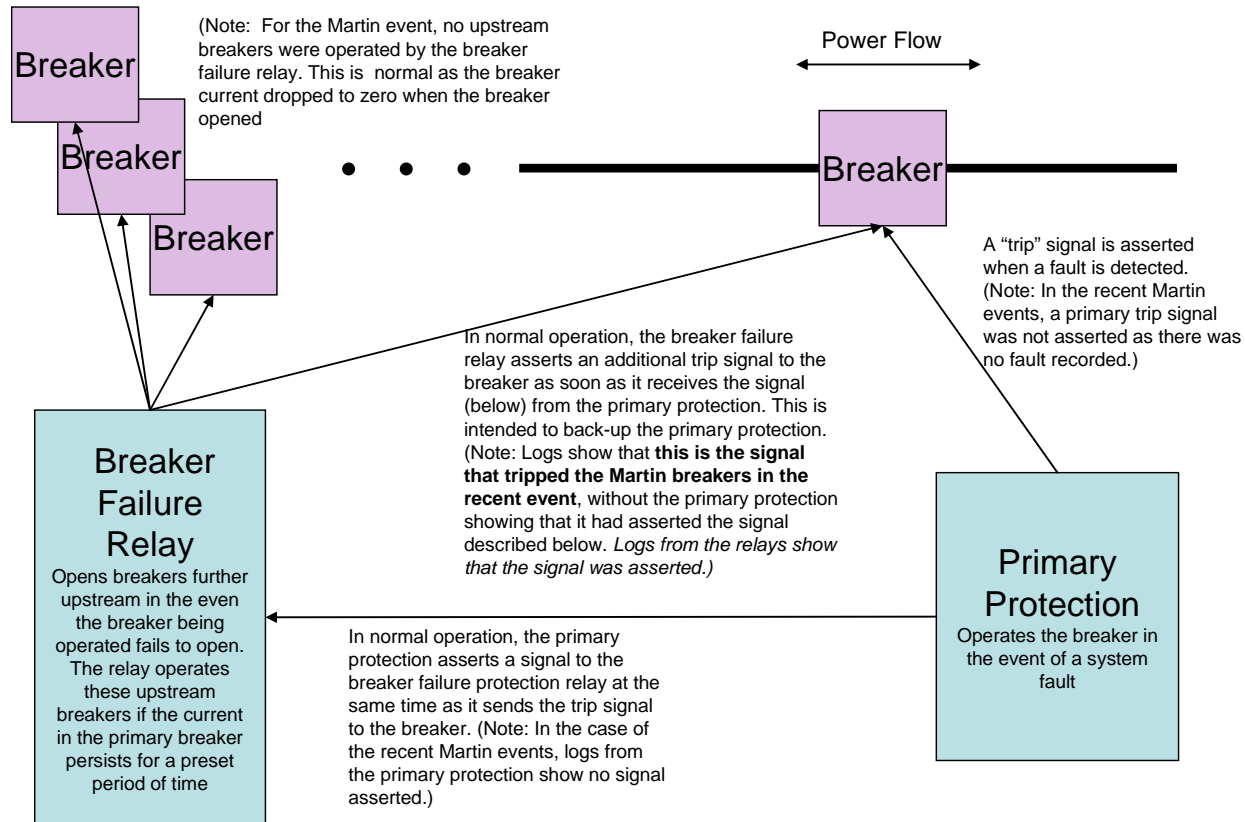
**FIGURE 3: Protection Scheme**

Each transmission circuit breaker is associated with another microprocessor-based device called a "breaker failure relay (BFR)." The BFR performs two functions (see Figure 3):

1. It sends a redundant trip signal (called a "re-trip") to trip the circuit breaker immediately.
2. If the circuit breaker fails to operate after a preset time, the BFR operates other breakers adjacent to the failed circuit breaker; thus providing backup protection and assuring faults are cleared.

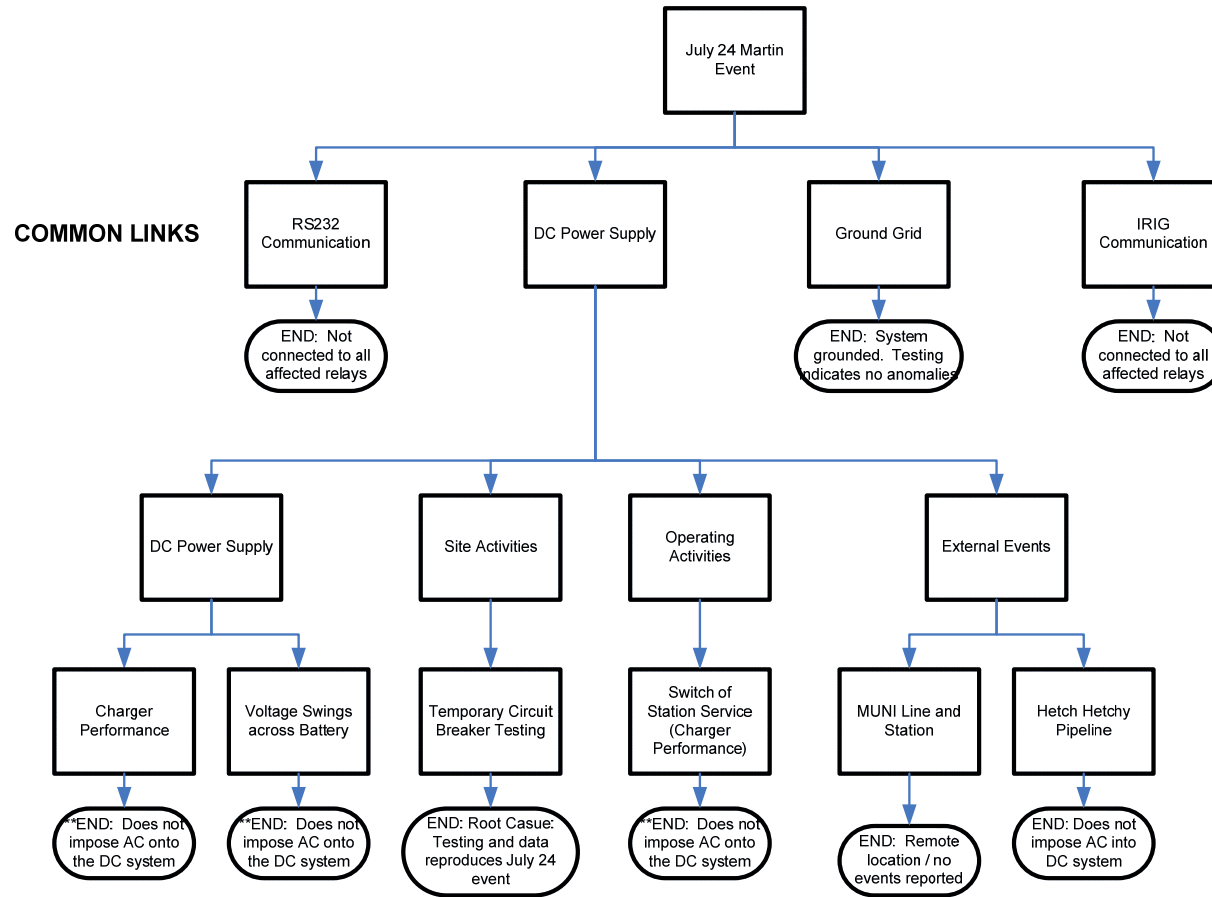
**FIGURE 5: Potential Initiating Causes**

The RS232 and IRIG were not connected to all of the affected breaker failure relays and were therefore eliminated. No scenario involving the grounding grid was found that was expected to induce false tripping. The DC power supply therefore became the focus of the investigation. Based on the breaker failure relay testing, an AC voltage on the DC supply was the only transient that reproduced the known July 24 relay behavior. The review of initiating events therefore focused primarily on conditions or actions that may have introduced AC voltage into the DC system. Figure 5 presents a flowchart showing the various causes considered and the status of the review for each possible cause.

There are four types of initiating events that were reviewed for the introduction of potential AC input into the station battery:

**\*\* On-going investigation relative to the March and April events. However, these are not a cause of the July 24 event.**
